**FINAL REPORT ON THE  
ENVIRONMENTAL TEST PROGRAM  
FOR THE  
ATMOSPHERE EXPLORER-B SPACECRAFT**

**SEPTEMBER 22, 1966**

**GODDARD SPACE FLIGHT CENTER**  
**GREENBELT, MARYLAND**

The AE-B spacecraft was launched May 25, 1966, from the Eastern Test Range (ETR) aboard a DSV-3c Delta launch vehicle (no. 38). Upon achieving orbit the spacecraft was renamed Explorer 32. Except for failures in the neutral particle mass spectrometer experiment and in the tape recorder, Explorer 32 continues to function well.

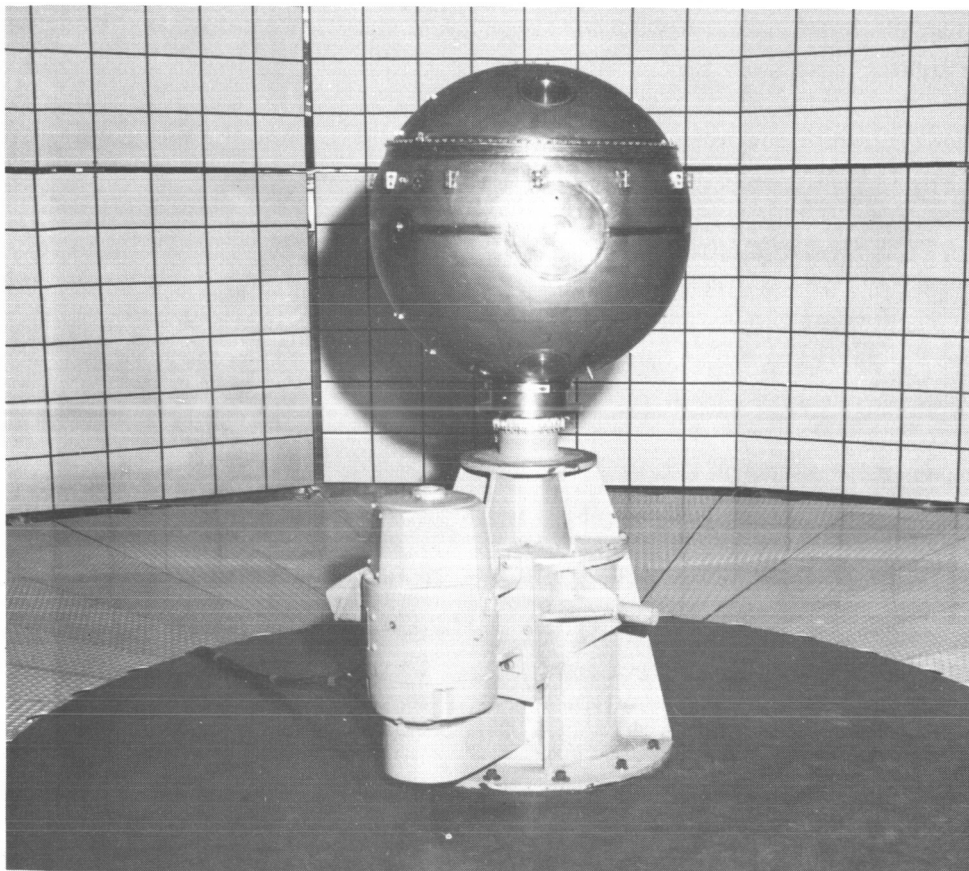
The static unbalance and spin axis moment of inertia were determined August 10, 1964, in preparation for a despin test in the Dynamic Test Chamber (Figure 1). The resulting static unbalance was 18 oz-in., the moment of inertia was 14.787 slug-ft<sup>2</sup>, and the weight with the yo-yo despin mechanism and dummy components installed was 458 lbs. The despin test was successfully conducted August 13, when the shell was despun from 60 rpm to a final corrected spin rate of 30.9 rpm in 1.5 seconds. The desired final spin rate was 30 rpm, and the chamber pressure at the time of the test was  $1.2 \times 10^{-2}$  mm Hg.

Figure 1—Shell no. 1 in dynamic test chamber after yo-yo despin test.

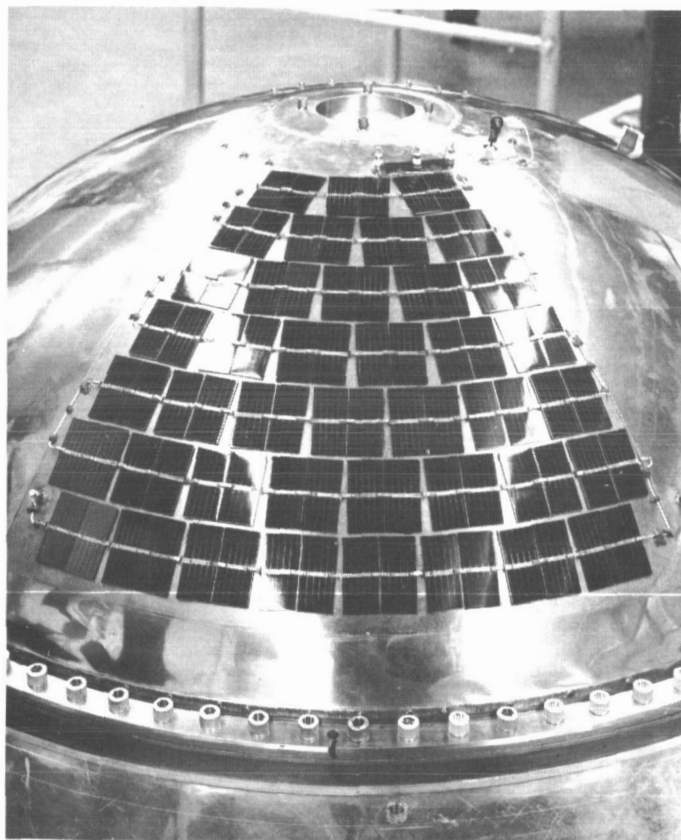
1. The design of the solar cells and the method of mounting the cells on the shell (Figure 3) were considered to be qualified in vibration.
2. The structure of shell no. 2 survived the new prototype Delta levels except for the low-frequency lateral sinusoidal tests at 2.3 g's; however, it survived the low-frequency lateral sinusoidal tests at 0.9 g's.

Figure 3—Shell no. 2 showing upper panel of solar cells.

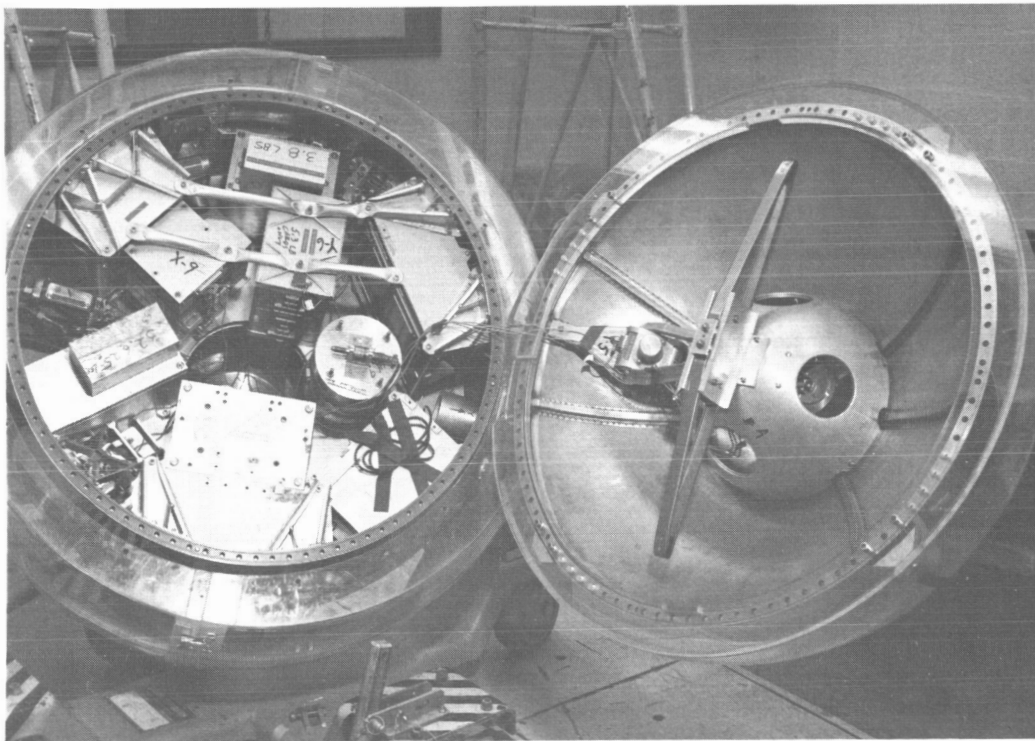
A series of vibration tests (Figure 4) were conducted in June and August 1964 to check out the new equatorial mountings of three experiments: the neutral particle mass spectrometer, the ion mass spectrometer, and the pressure gage. In preparation for the test, the static unbalance was determined June 9 to be 167 in.-lbs but after shifting one dummy package, the resulting static unbalance was 66 in.-lbs. The weight of the structural model was 394 lbs. A prototype-level vibration test was successfully completed on the structural model June 12-15, thus qualifying the equatorial mountings of the three experiments. Another test result was an apparent input level buildup at low-frequencies in the lateral directions. Subsequent vibration tests on August 3 and 12 proved that the level buildup was caused by the mounting of the control accelerometer on a cylindrical surface; however, the amplitude of the structural model continued to increase as the frequency decreased to 8 cps in the lateral direction. On August 6 the structural model static unbalance and spin axis moment of inertia were determined; the resulting static unbalance and moment of inertia were 74 in.-lbs and 13.013 slug-ft<sup>2</sup>, respectively. The structural model weight was 396 lbs.

Figure 4—Shell no. 3 (Structural Model) showing some of the accelerometer instrumentation prior to a vibration test.

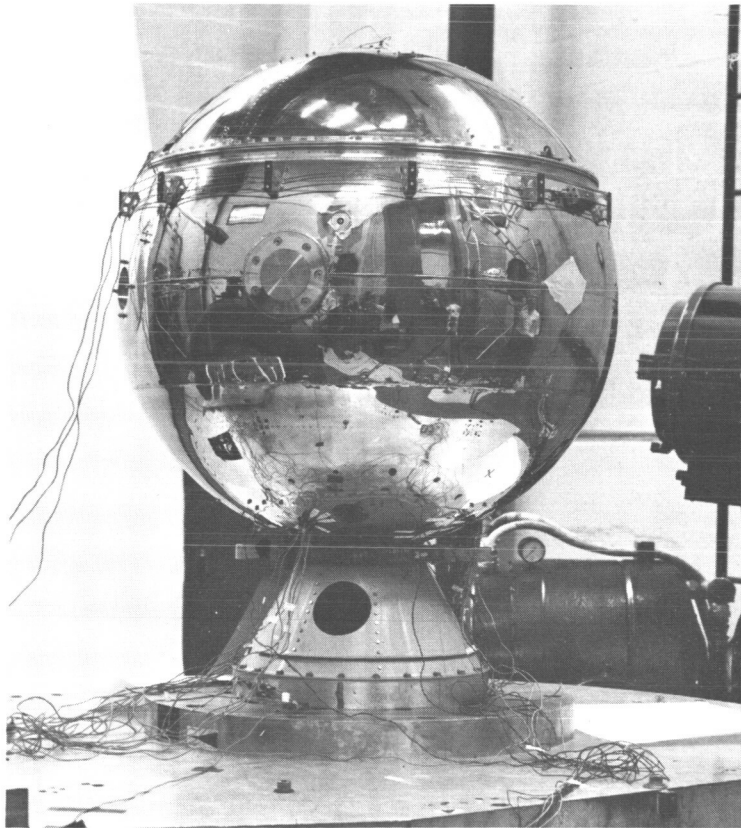
Vibration tests - June 1965 (Figure 7.) Two 0.5 g, 30-8 cps,  $Y^1 - Y^1$  direction, sinusoidal vibration tests were conducted on June 4. The first test was conducted with no shimming, and the second test was conducted after shimming the spacecraft base. Although a better fit was achieved by shimming, which in turn probably reduced the gapping, "banging" was not significantly reduced according to oscillograph data. The Q at the spacecraft center of gravity (C.G.) actually increased from 4.5 to 6.5 as a result of shimming. The shell rotated slightly in the clockwise direction, as viewed from the top, until it was stopped by the seating of the clamp key. The torque measured during the test was about 300 ft-lbs, and the lateral resonance occurred at 15 cps.

Figure 7-Shell no. 6 undergoing vibration tests in June 1965.

On June 5 the shell was aligned in preparation for dynamic balancing (statically balanced prior to vibration); dynamic balancing began June 7. Inspection of the shell interior on June 8 while on the balancing machine revealed that two gussets at the shell base were slightly bent. This was a result of the 1.0 g lateral vibration test conducted May 24 and indicated that the test was more severe than originally estimated. Balancing continued until June 9, when a decision was made to remachine the shell base to improve the surface flatness. The shell was removed, disassembled, and taken to building 5 for remachining. Balancing was resumed June 19 and was completed June 21. The residual static and dynamic unbalance were 46 oz-in. and 381 oz-in.<sup>2</sup>, respectively, and the total weight after balancing was 481 lbs. The C.G. of the shell was 17.05 inches above the interface.

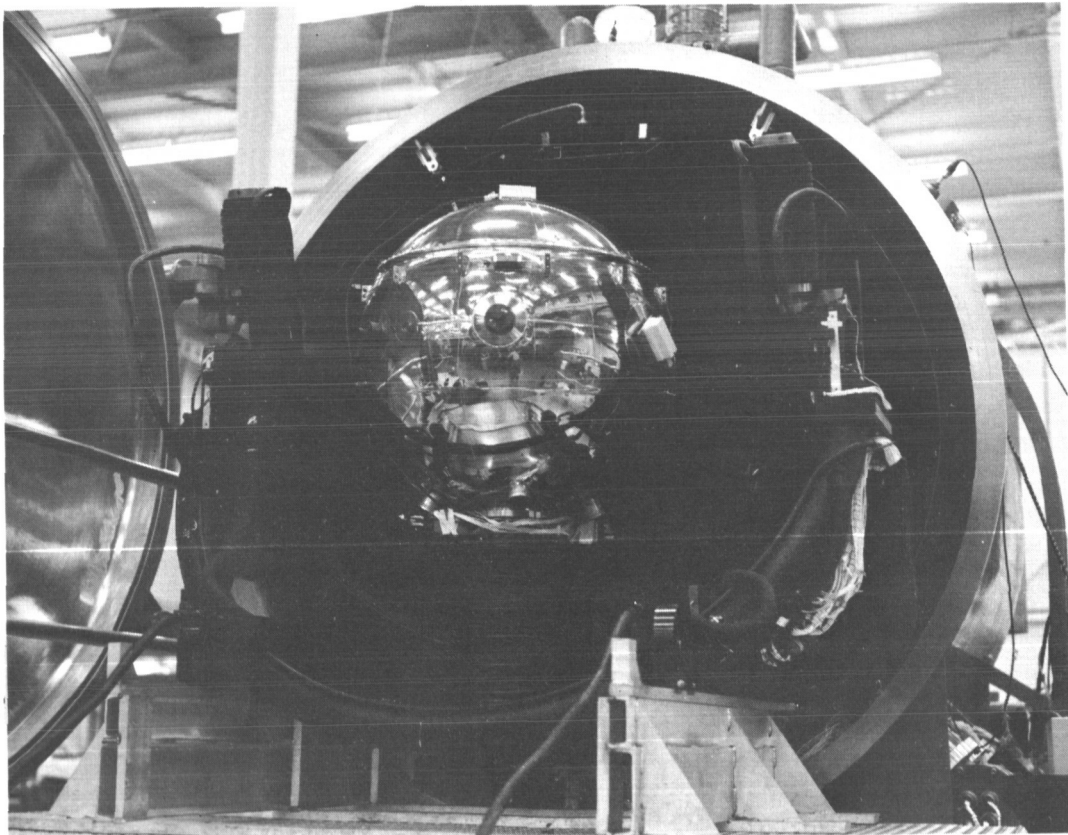
Preliminary Solar Simulation Tests (Figure 8.) A preliminary solar simulation test in the 7' x 8' solar simulation chamber began on January 12, 1966 and was terminated later that day because the gimbal spin motor would not rotate the spacecraft at an aspect angle of 0°. The test was resumed January 13, but was stopped January 14 because the spin motor would not rotate the spacecraft at aspect angles of 135°, 0°, and some intermediate angles. The spin motor was repaired January 15 and 16, and the test was resumed January 17, but on January 18 the spin motor again failed at an aspect angle of 0° after working for about 30 minutes. On January 19 shell no. 6 was removed from the gimbal and the static unbalance was measured and found to be 4.83 ft-lbs. The torque generated by the gimbal spin motor in the 7' x 8' chamber was 3 to 4 ft-lbs and was therefore not sufficient to rotate the shell at some aspects. The shell was statically balanced February 9 to an unbalance that varied from .55 to 1.975 ft-lbs depending on the orientation of the shell on the Miller Facility. Based on a vector analysis, a weight was subsequently added to the shell which reduced the unbalance to less than 1 ft-lb.

Figure 8—Shell no. 6 prior to solar simulation test.

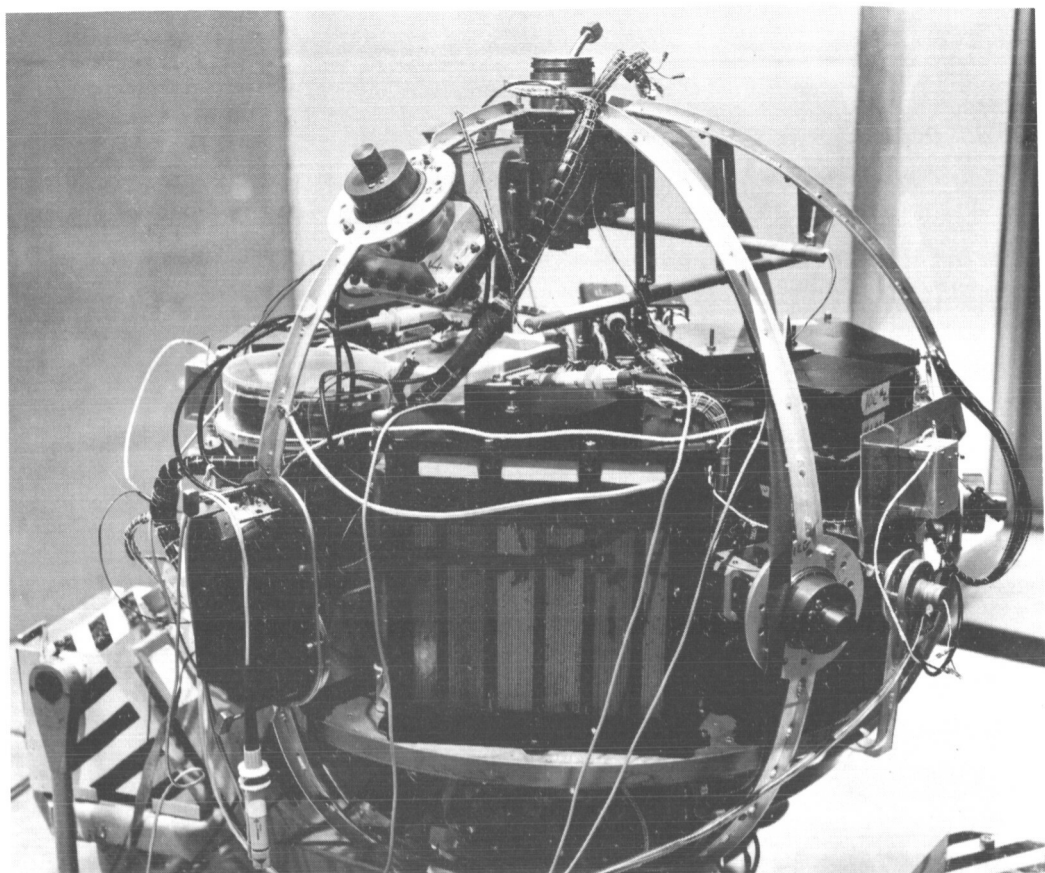
A preliminary temperature test began on the mock-up spacecraft February 19, 1965 (Figure 9) and was terminated temporarily February 21. During this period several spacecraft checkouts were conducted between  $-10^\circ\text{C}$  and  $45^\circ\text{C}$ , which indicated that the equatorial neutral-particle mass spectrometer was noisy at  $-10^\circ\text{C}$ . The tape recorder exhibited some noise the first time at  $-10^\circ\text{C}$  but not the second time; electron temperature probe no. 2 evidenced some 60 cps noise at  $-10^\circ\text{C}$ , and at  $45^\circ\text{C}$  the turn-on counter experienced a failure in one stage. Otherwise, the spacecraft electronics functioned satisfactorily. An ambient temperature checkout on February 23 was satisfactory except for the turn-on counter. Prior to beginning the temperature test some difficulty was experienced with the magnetic attitude and spin rate control electronics, and it was removed from the system for modification.

The temperature test on the mock-up spacecraft resumed March 3 and was concluded March 6. During this period, spacecraft checkouts were conducted at  $-10^\circ\text{C}$  and  $45^\circ\text{C}$ . At  $-10^\circ\text{C}$  a problem was noted with the tape recorder/telemetry interface circuitry which was solved by incorporating two diodes in series into the circuitry. Subsequent spacecraft checkouts at  $-10^\circ\text{C}$  and  $45^\circ\text{C}$  were found to be satisfactory. The magnetic attitude and spin rate control electronics were in the system during this period and functioned satisfactorily but the ion mass spectrometer was not. It was checked out satisfactorily during the first temperature cycle February 19-21 and was returned to the experimenters for calibration.

Figure 9—Mock-up spacecraft undergoing temperature test in 12'  $\times$  12'  $\times$  20' temperature chamber.

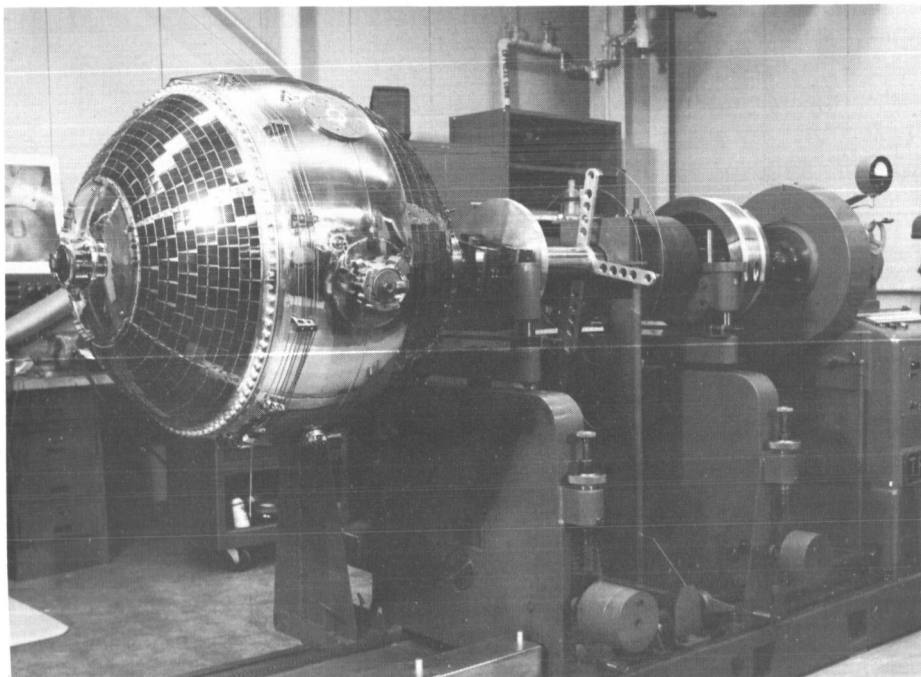
Figure 12—Flight spacecraft in final balance operation.

Final balancing. Final balancing of the flight spacecraft (Figure 12) was accomplished during the period March 28-30, 1966. The spacecraft was balanced in the orbital configuration to an unbalance of 9 oz-in. static and 205 oz-in.<sup>2</sup> dynamic. The spacecraft unbalance was then measured for the launch configuration and was found to be 327 oz-in. static and 980 oz-in.<sup>2</sup> dynamic.
